WEAR TAB FIELD REPAIR FOR EZ BEDLIFT

IN THE EVENT THAT A WEAR TAB IS DISLODGED FROM THE EZ BEDLIFT TROLLEY, FOLLOW THE PROCEDURE BELOW TO REPAIR THE SYSTEM:

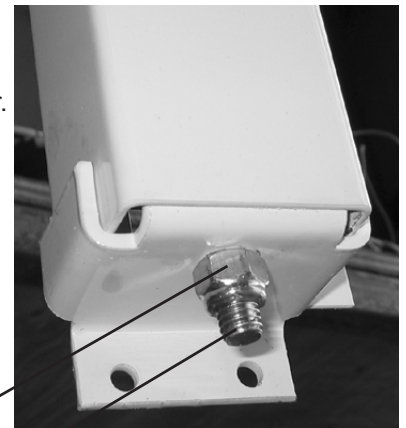
Bottom of Assembly

1. Remove the nut from the bolt at the bottom of the assembly where the wear tab has become dislodged.
2. Remove the plate from the bottom of the assembly.
3. Tap firmly on the bolt and tension assembly to free the wear tab from the chain and gear.

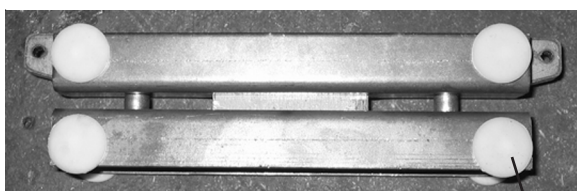
TROLLEY ASSEMBLY

NOTE: The system will efficiently operate WITHOUT wear tabs on the trolley but will make noise from the metal to metal contact.

WEAR TABS

4. Check trolley for any other loose or lost wear tabs.
5. To replace wear tabs into trolley, the entire mechanism from the side effected must be removed from the wall.
6. Lift beds and/or dinette out of the trolleys and set them aside.
7. Disconnect cross shafts. Telescope the cross shafts out of the way.
8. Remove screws from the wall holding mechanism in place.
9. Remove mechanism from unit and lay facedown on a flat surface.
10. Pull trolley(s) out of the channel(s) and replace missing wear tab(s). Secure wear tabs in place with a silicone adhesive.
11. Return the trolley to the channel.
12. Secure the mechanism back in place on the wall.
13. Replace beds and/or dinette.
14. Replace bottom plate and 9/16" nut.
15. Be sure the beds and/or dinette is timed correctly and runs without a hitch..
