COACHMEN MOTORIZED N500 MOTOR CHANGE PROCEDURE

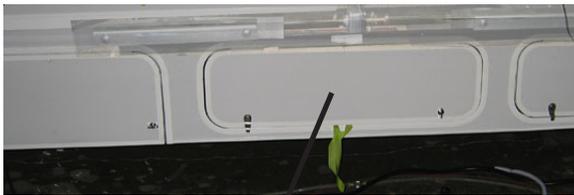
Fig. 1

Most models of Coachmen units have relatively easy access (Figs. 1) to the Above Floor Slideout Motor. Access is gained through the middle compartment (Fig. 1-A) on the driver's side of the coach. On Maverick, Frelander and Leprechaun models (Fig. 2), the access is through a smaller compartment and the motor is offset and a bit more difficult to reach. Follow the procedure below for all Coachmen and Georgie Boy Above Floor Sofa Slide N500 motor replacements.

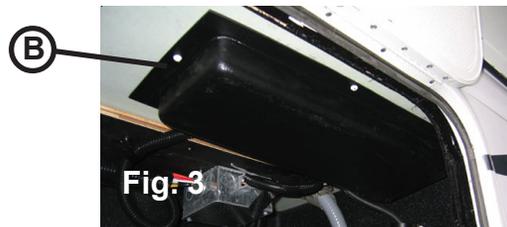
Fig. 3

1. Open middle cargo door (A) on the driver's side of the coach.
2. Remove the ABS plastic motor cover (B) mounted to the ceiling of the cargo compartment.

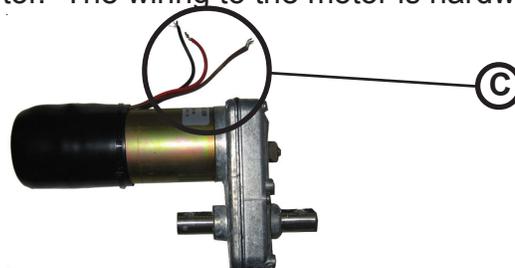
(C)

3. Disconnect the power source to the motor. The wiring to the motor is hardwired and must be cut to disconnect.

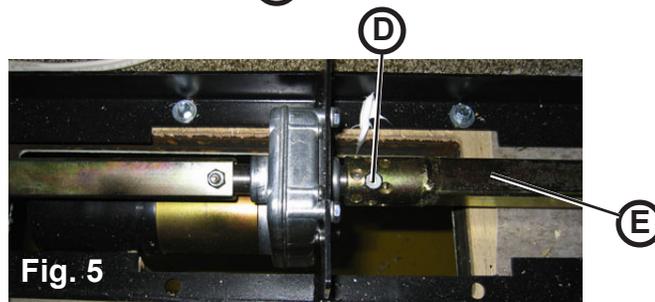
Fig. 5

4. With a 7/16" wrench, remove nut and bolt (D) on the cross shaft with the adjustable timing tube (E).

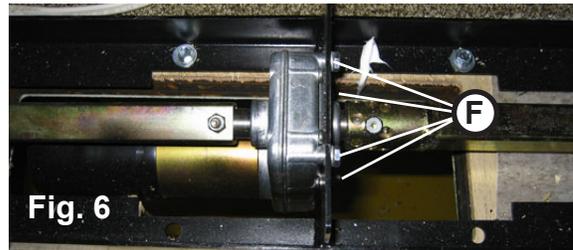
5. With the 7/16" wrench, remove the four (4) motor mount bolts (F) disconnecting the motor from the mount.

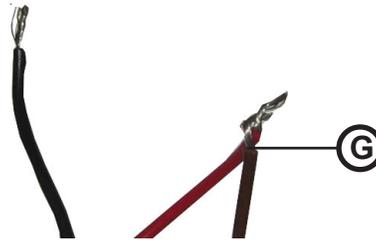
6. Remove the nut and bolt from the cross shaft on the opposite side of the motor.
7. Remove the motor from the coach.
8. Twist the brown and red stripped wire ends on the replacement motor together (G).

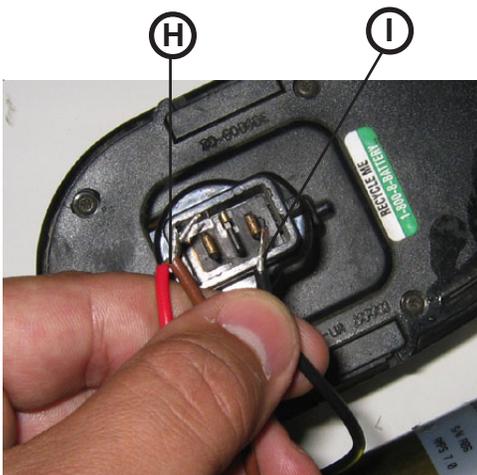
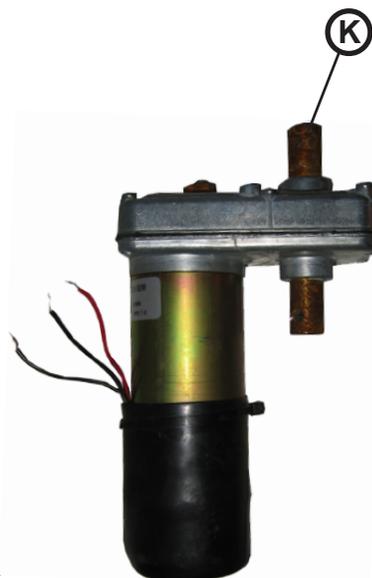
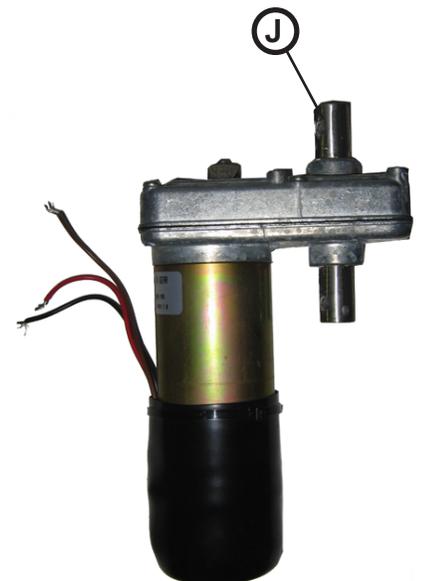
9. Using a cordless drill battery, touch the brown and red wires (H) {positive (+)} and the black wire (I) {negative (-)} to the battery terminals until the replacement motor drive shaft (J) is realigned to the same position as the bad motor drive shaft (K).
