Lippert Components, Inc. Informational Publication

LIP Sheet - 0062

FIELD FIX FOR NORTHWOOD ELECTRIC THROUGH FRAME

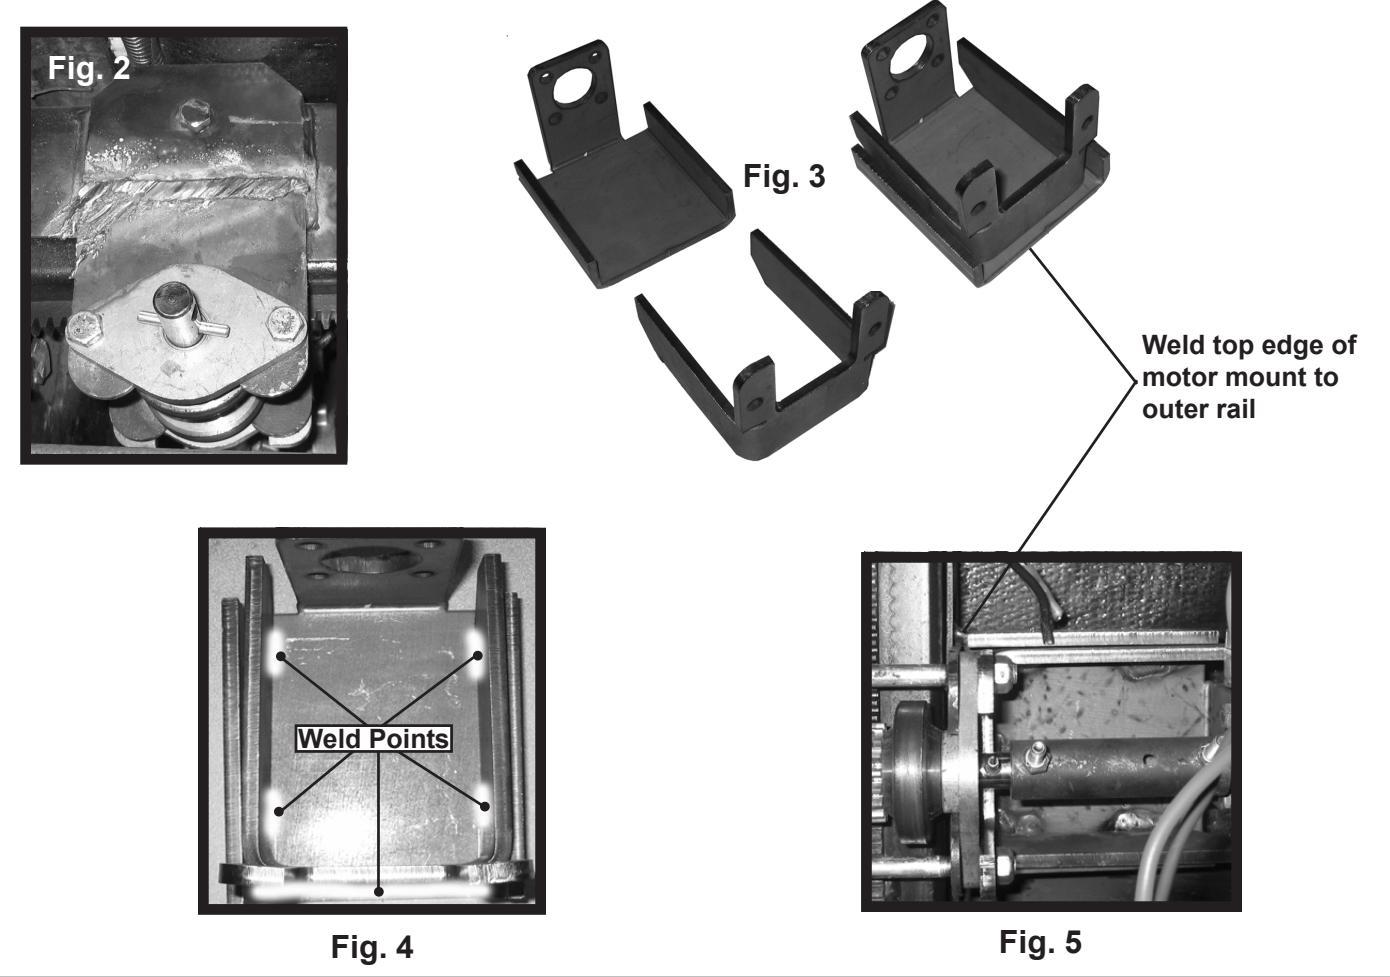
With the slideout motor mounted off one end of the system, an excessive amount of torque is applied to the gear pack mounted directly to the motor. This excessive torque results in a broken drive shaft on the gear pack. See Fig. 1

- Step 1 Disconnect power from motor.
- Step 2 Remove motor from motor mount.
- Step 3 OPTIONAL Remove motor mount from outer rail of slideout. See Fig 2. This step is optional because the bracket can be left in place if new motor mount assembly (see Fig. 3 & 4) is available.
- **NOTE:** Fig. 4 shows the weld points to weld the motor mount assembly together. Figs. 3 & 5 show assembly completed and welded in place respectively.

To fix this slideout unit, simply replacing the gearpack will not work. The motor itself must be moved to an inside position so that torque is more evenly applied to both gear packs. To complete this process, follow directions listed below.

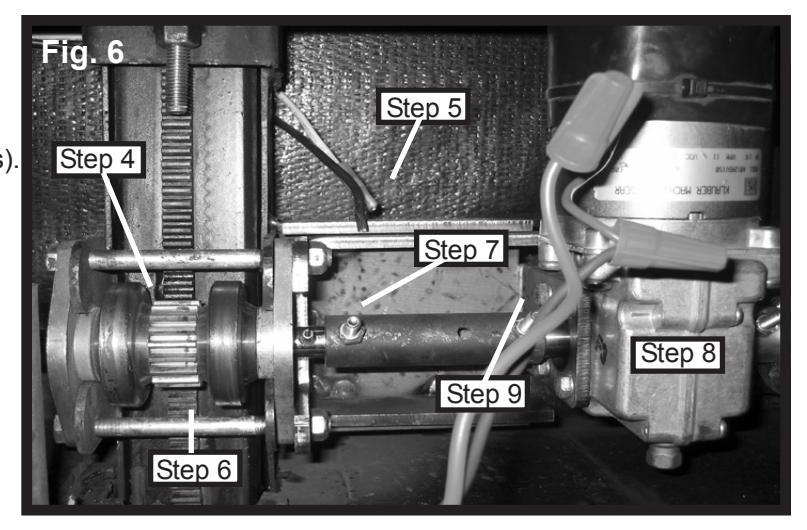
See Fig. 6 for following steps:

- Step 4 Remove broken gear pack.
- Step 5 Weld motor mount to the inside of the outer rail.
- Step 6 Replace broken gear pack with new gear pack.
- (Be sure to use 3/8 16 x 5 1/4-5 1/2" GR5 bolts). Must be inserted from motor side to prevent interference with cross shaft bolt.
- Step 7 Bolt new drive coupler into place.
- Step 8 Bolt motor to mount.
- Step 9 Bolt motor drive shaft to drive coupler.

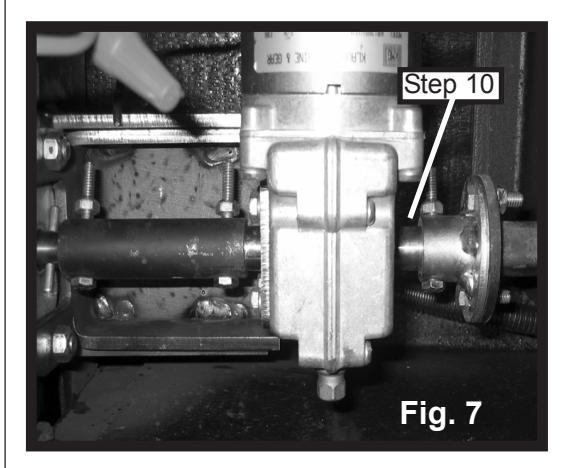
Step 10 - Bolt NEW timing adapter in place. see Fig. 7

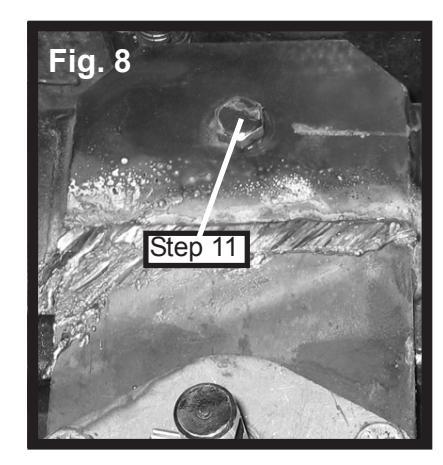
Step 11 - Check roller (see Fig. 9) above gear pack assembly for free rolling movement. Be sure to check the roller when the slideout is in the extended position See Fig. 8 for location. Roller should roll freely on the shoulder bolt. If bolt rotates WITH the roller, shoulder bolt must be tapped out with a hammer and the hole through roller must be drilled out so it will roll freely on the shoulder bolt.
