DZ 43203

DZ 43203 FORD TAILGATE ASSIST F-150 1997-2003 SUPERDUTY 1999-2016

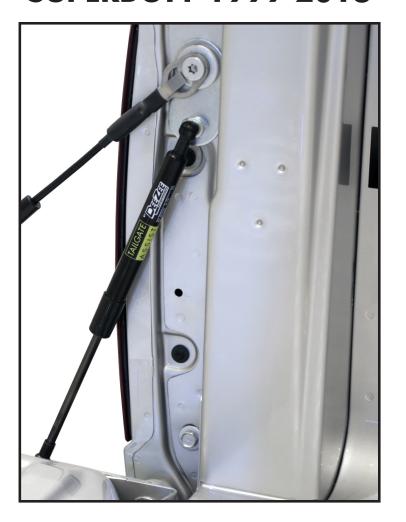
SHOCK 1
BALL MOUNT PLATE 1
BLIND NUT TOOL 1
BALL MOUNT 1
BLIND NUT/NUTSERT 1
TORX WRENCH 1
MYLAR 1
